HARFORD COUNTY DPW

LOWER BYNUM RUN SMALL WATERSHED ASSESSMENT REPORT

DECEMBER 13, 2019

HARFORD COUNTY DEPARTMENT OF
PUBLIC WORKS

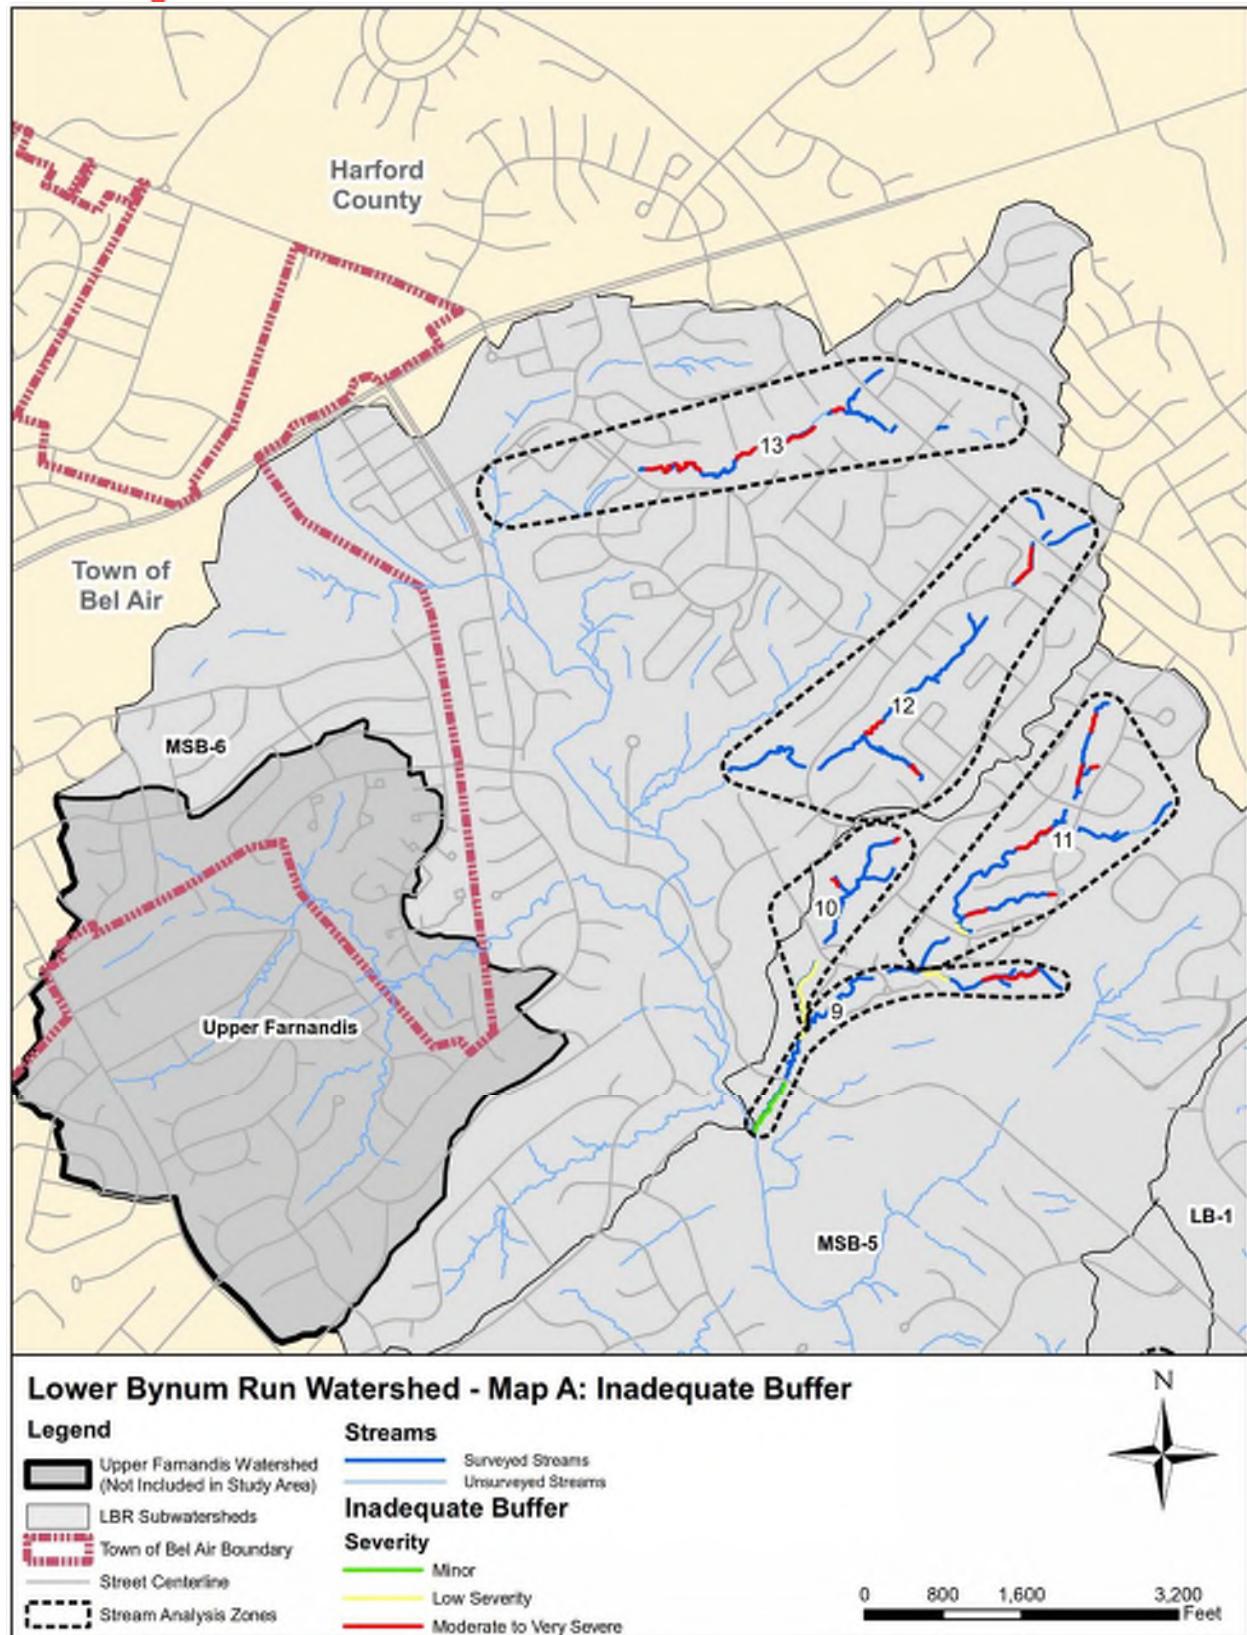
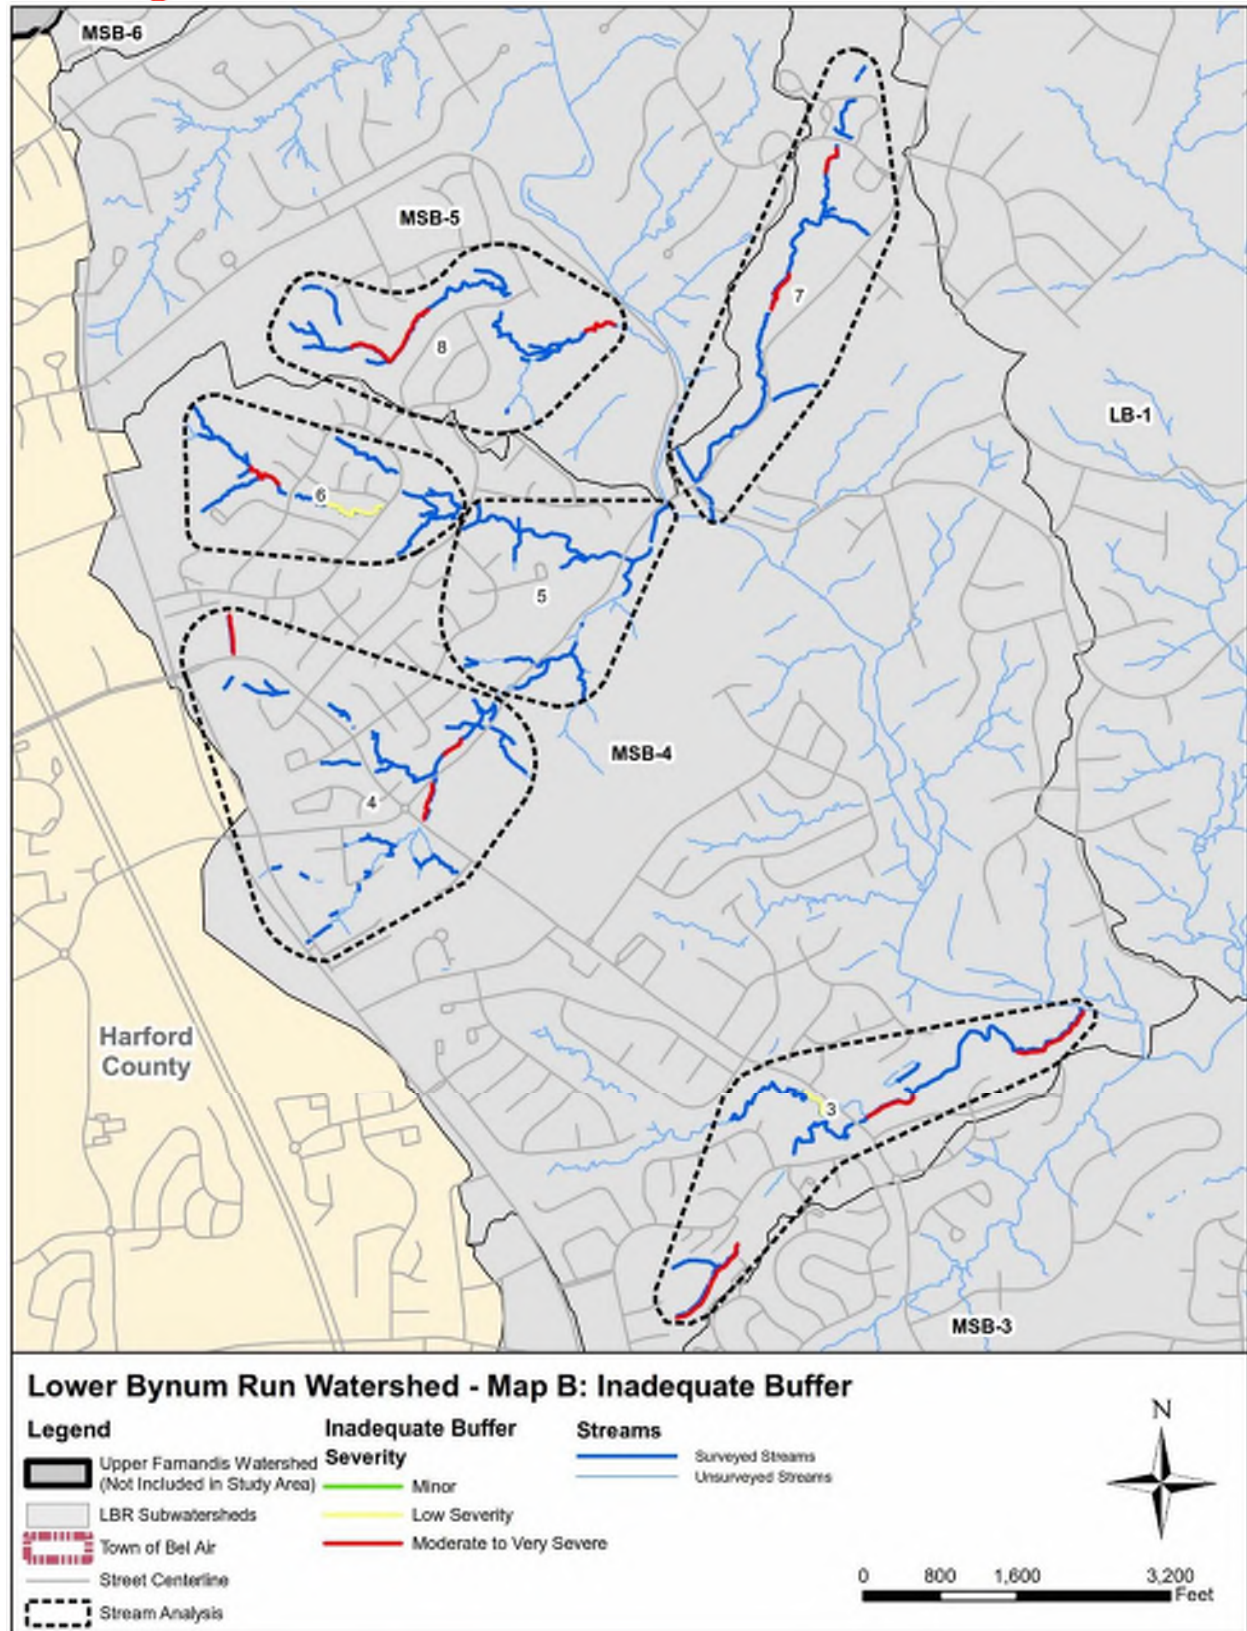
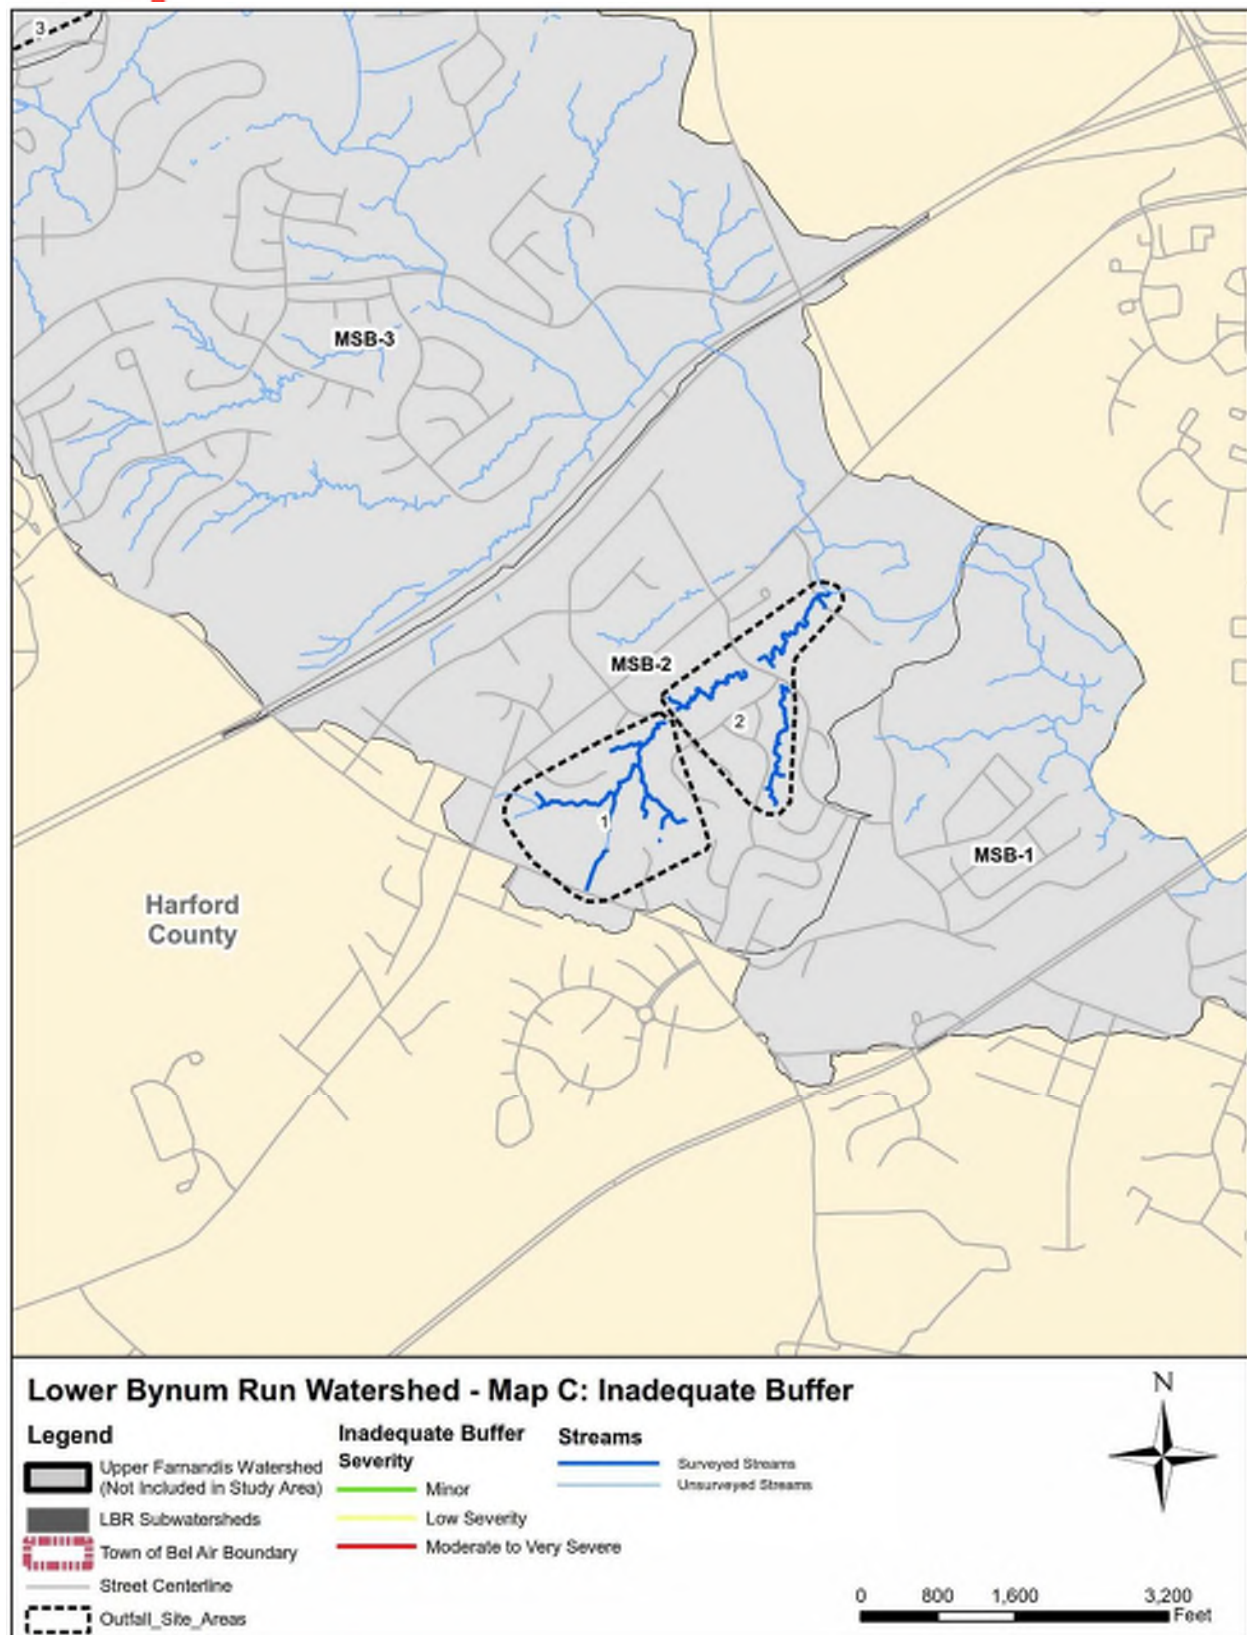
Most of the inadequate buffer sites were in MSB-4 and MSB-5; approximately 17% of all streams assessed were identified as having some sort of inadequate buffer. Many of the inadequate buffers are due to residential lawns. Unshaded conditions can be detrimental to aquatic life as shade protects streams from excessive solar heating. A TMDL listing for temperature in the watershed indicates that unshaded reaches are currently experiencing solar heating. The locations of stream segments with inadequate buffers and their corresponding severity ratings are shown in Figure 4-12 through Figure 4-14.

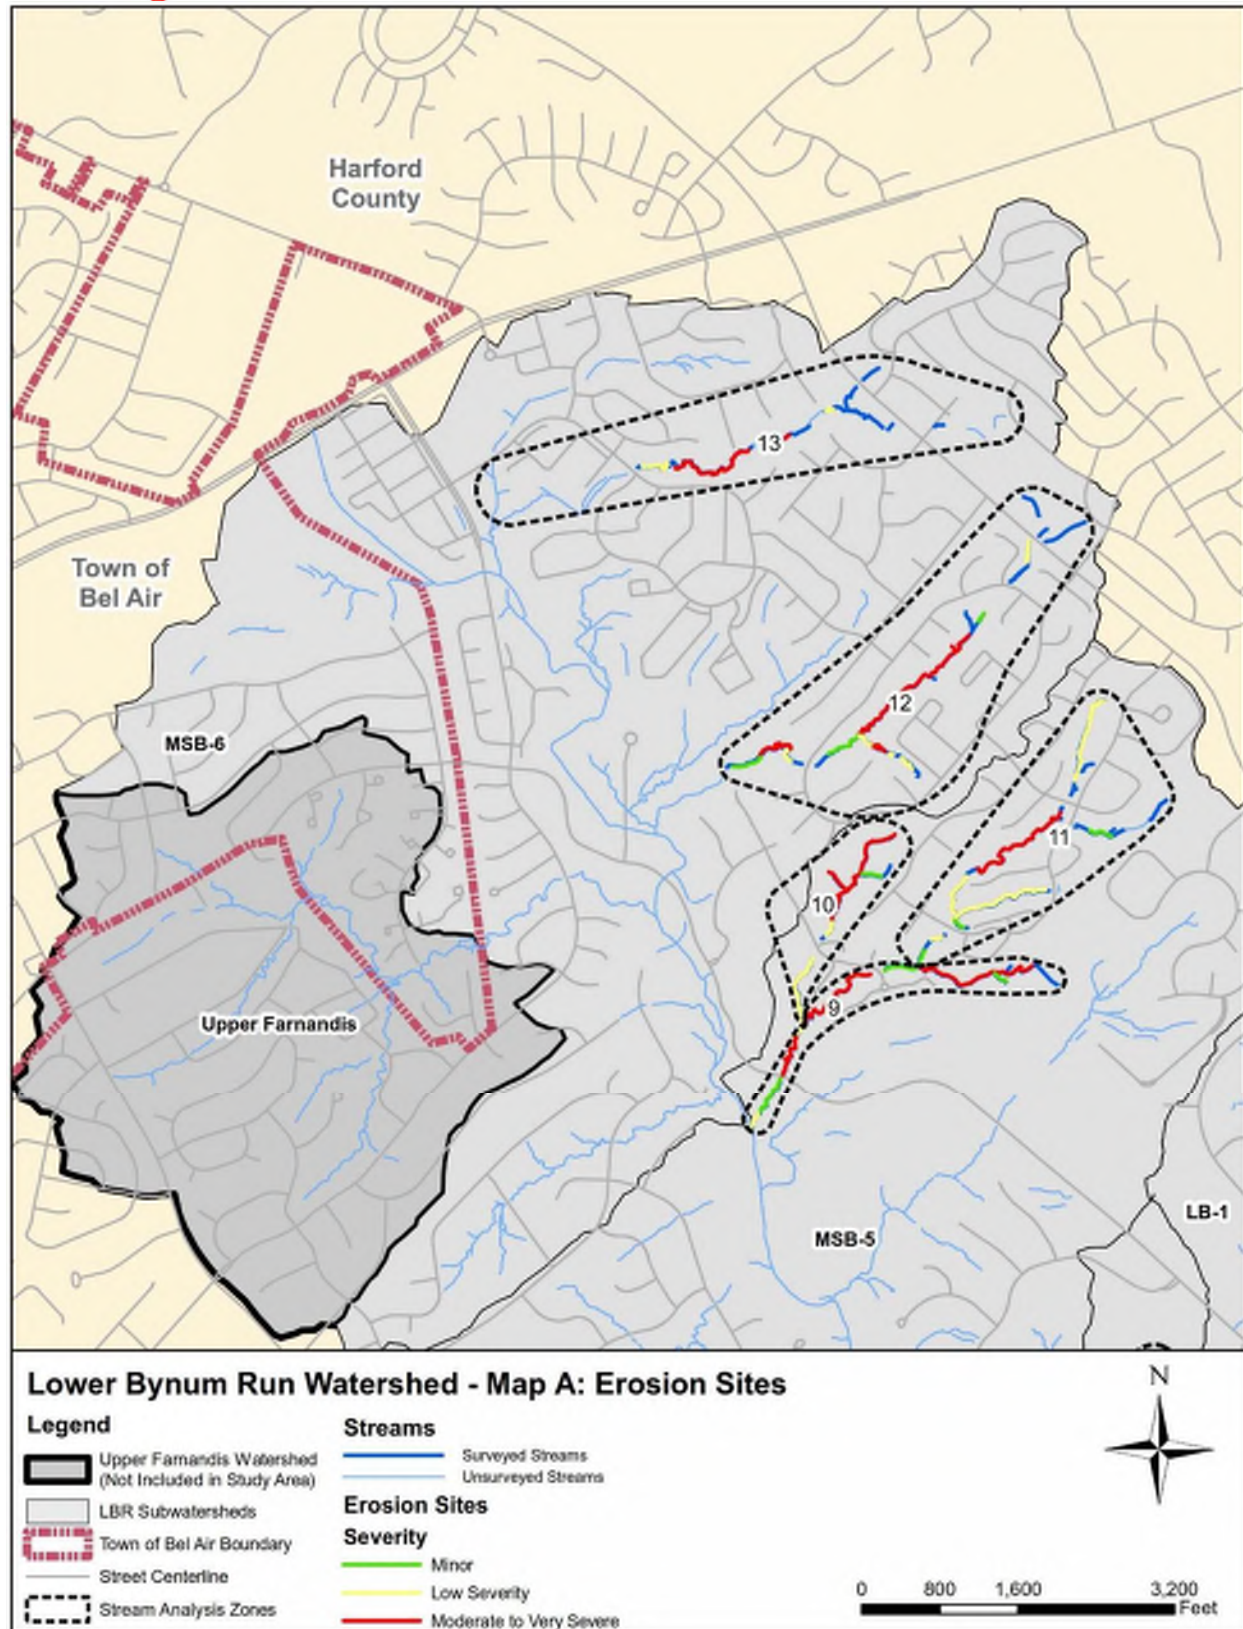
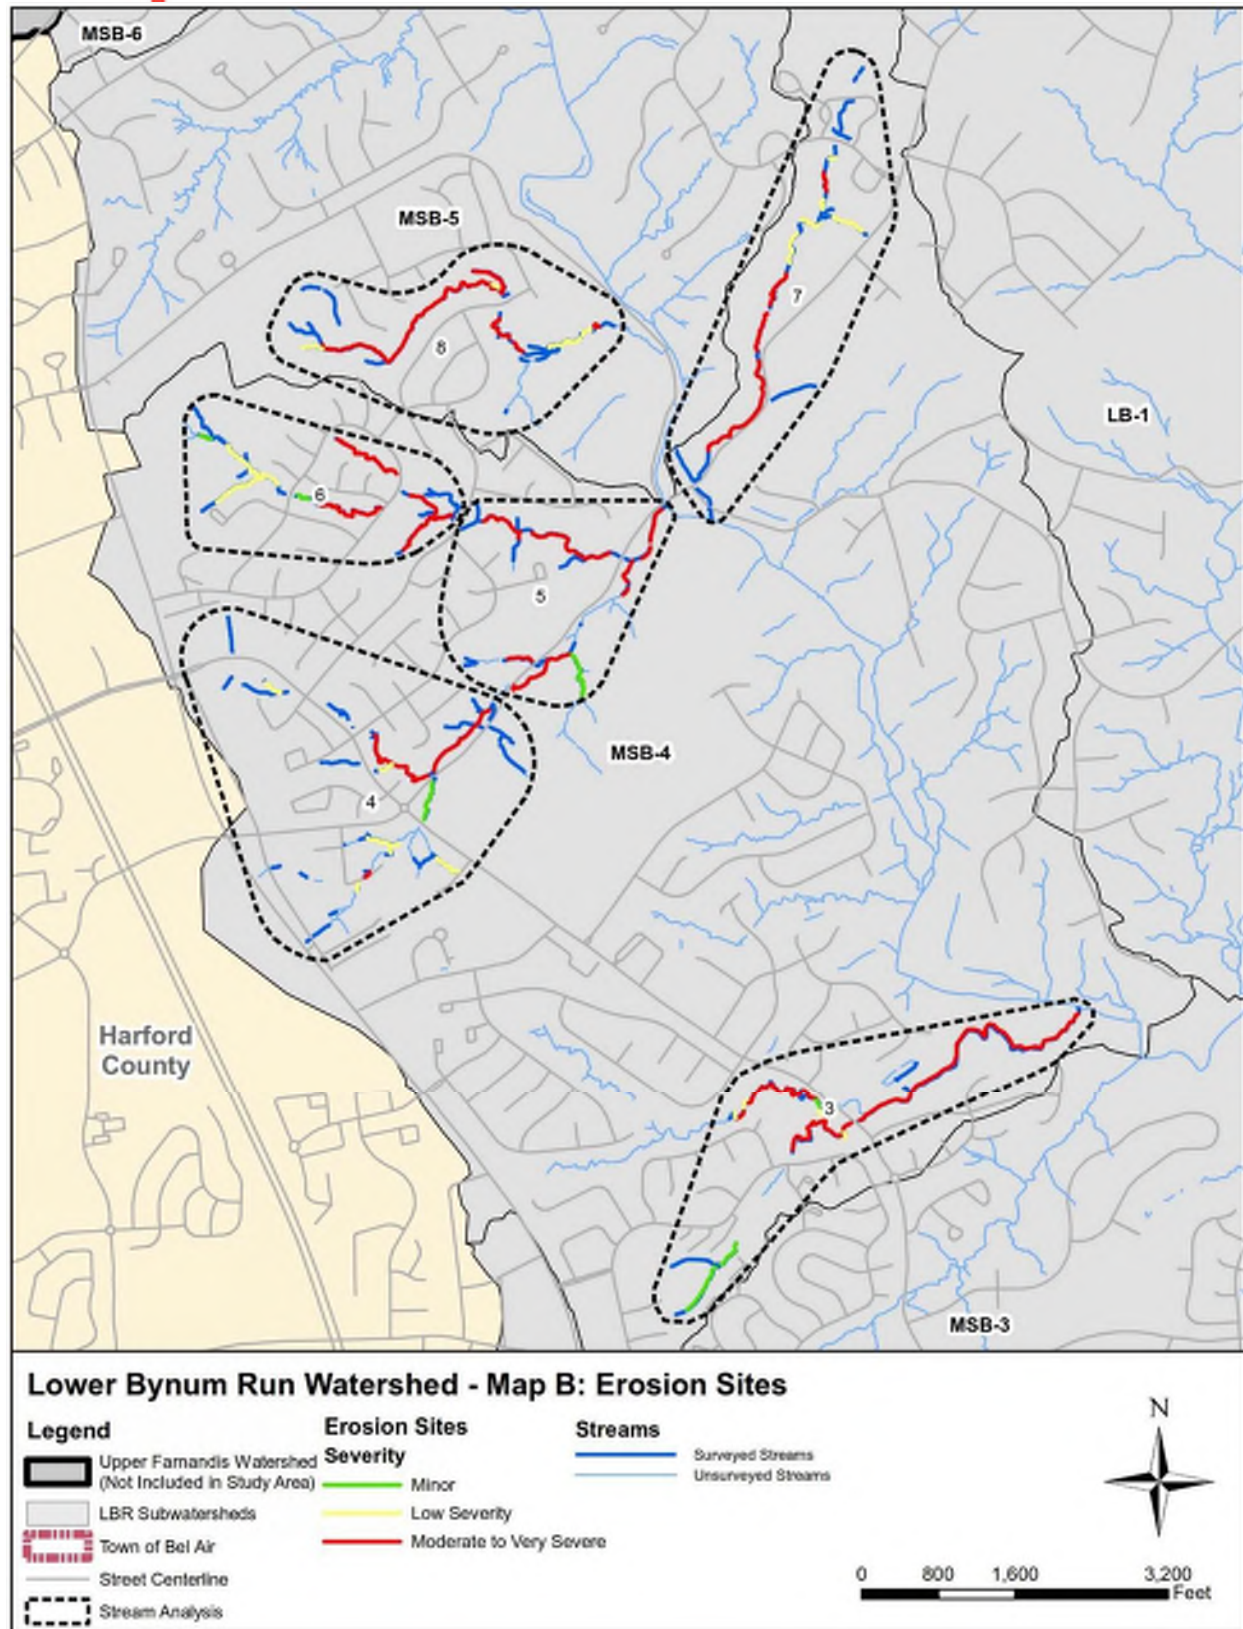
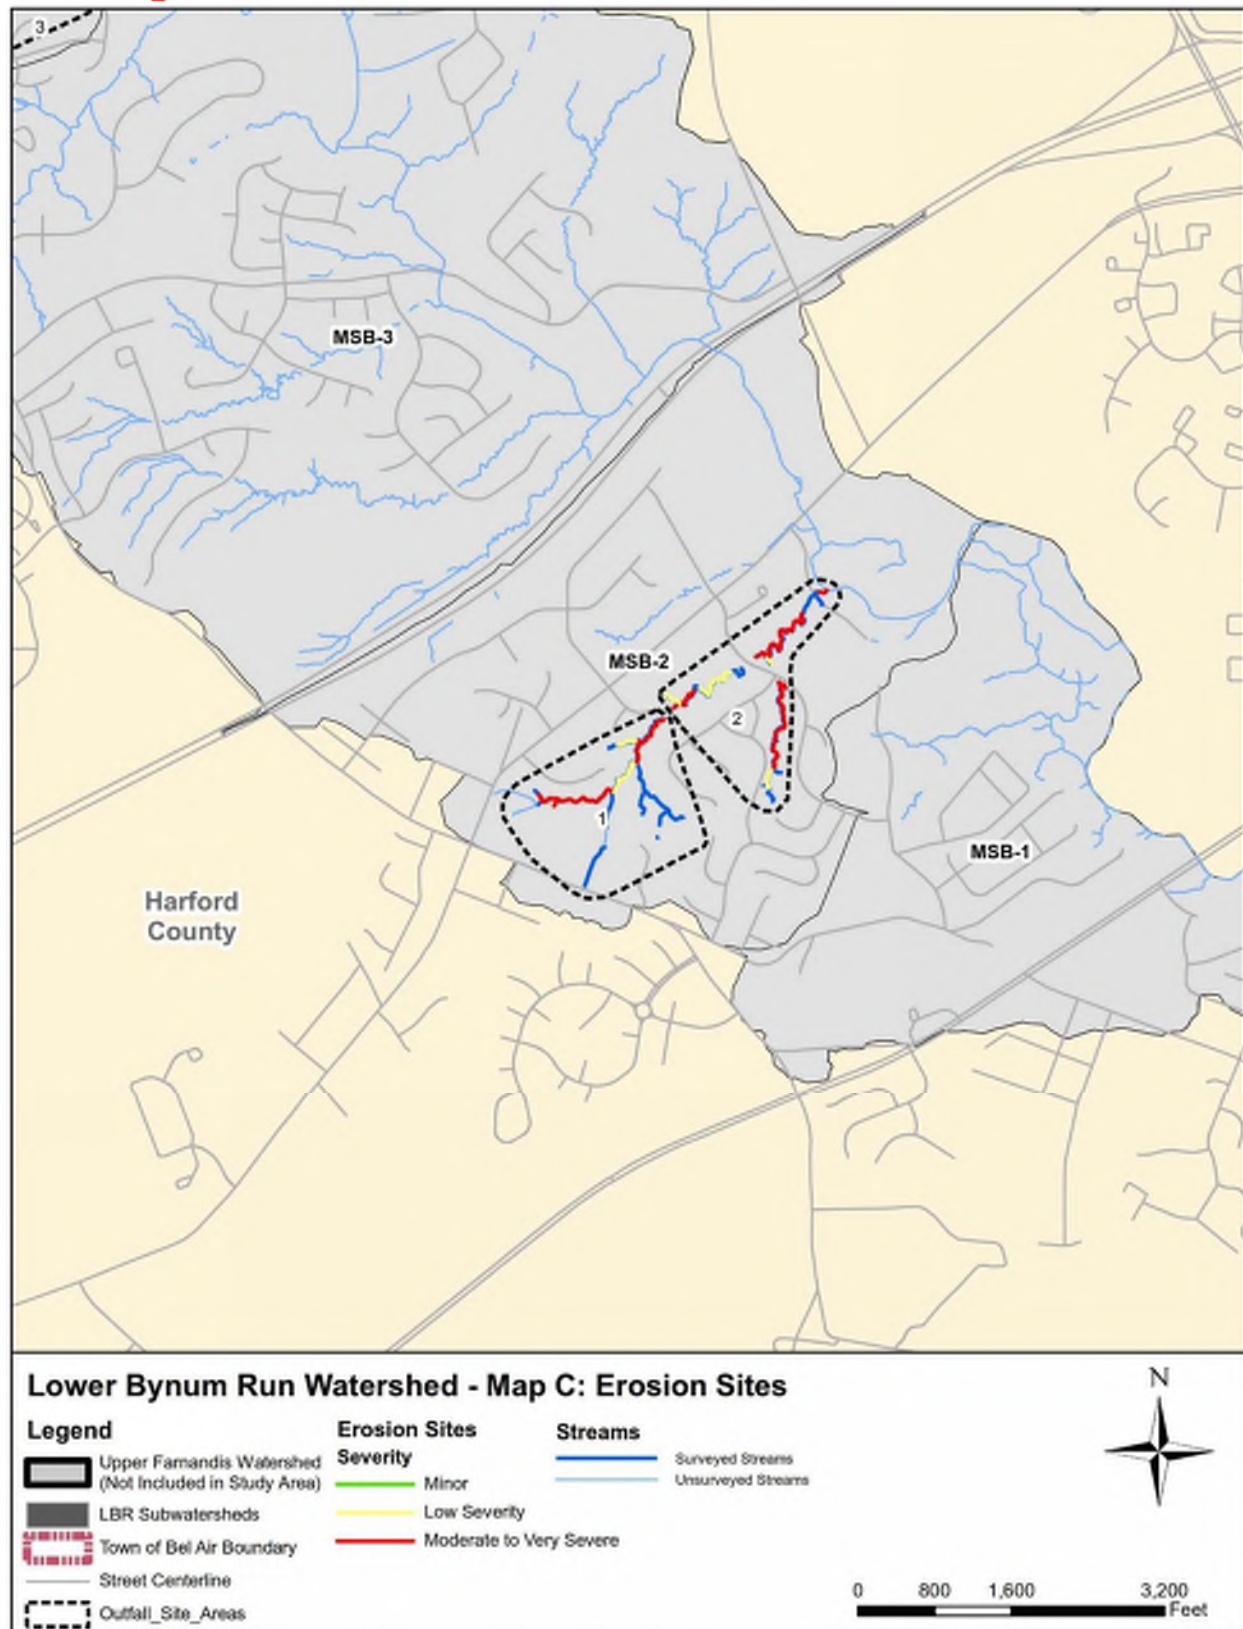
Stream bank erosion is a natural process necessary to maintain a healthy aquatic habitat. Conversely, too much erosion can have the opposite effect on a stream system by destabilizing banks, destroying in-stream habitat, and causing sediment pollution problems downstream. Significant erosion problems are the result of changes to stream hydrology or sediment supply which is often attributed to land use changes in a watershed (e.g., urbanization, increased impervious cover). This results in a much greater in-stream flow rate during storm events and leads to eroded streambeds and banks. Although streams in forested areas may have adequate 50-foot forest buffers, they can also experience erosion problems due to these high flows from upstream.

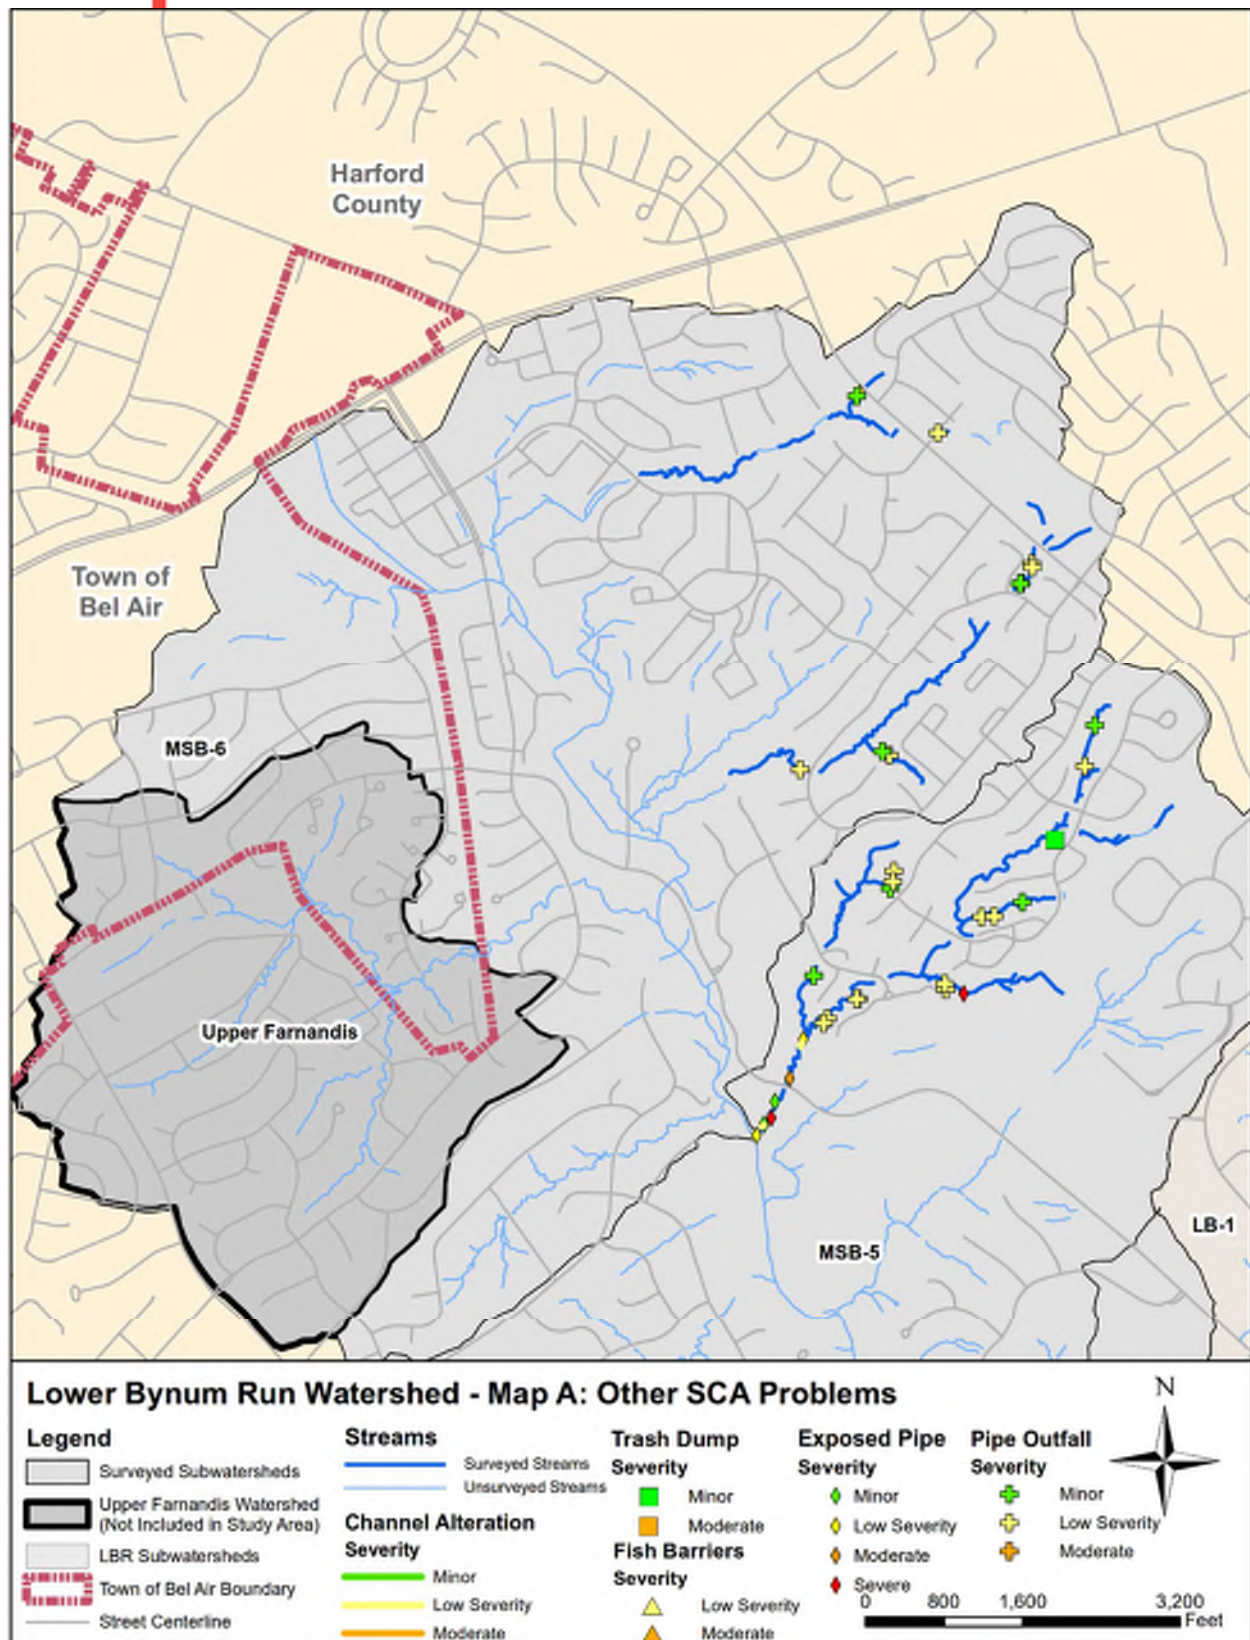
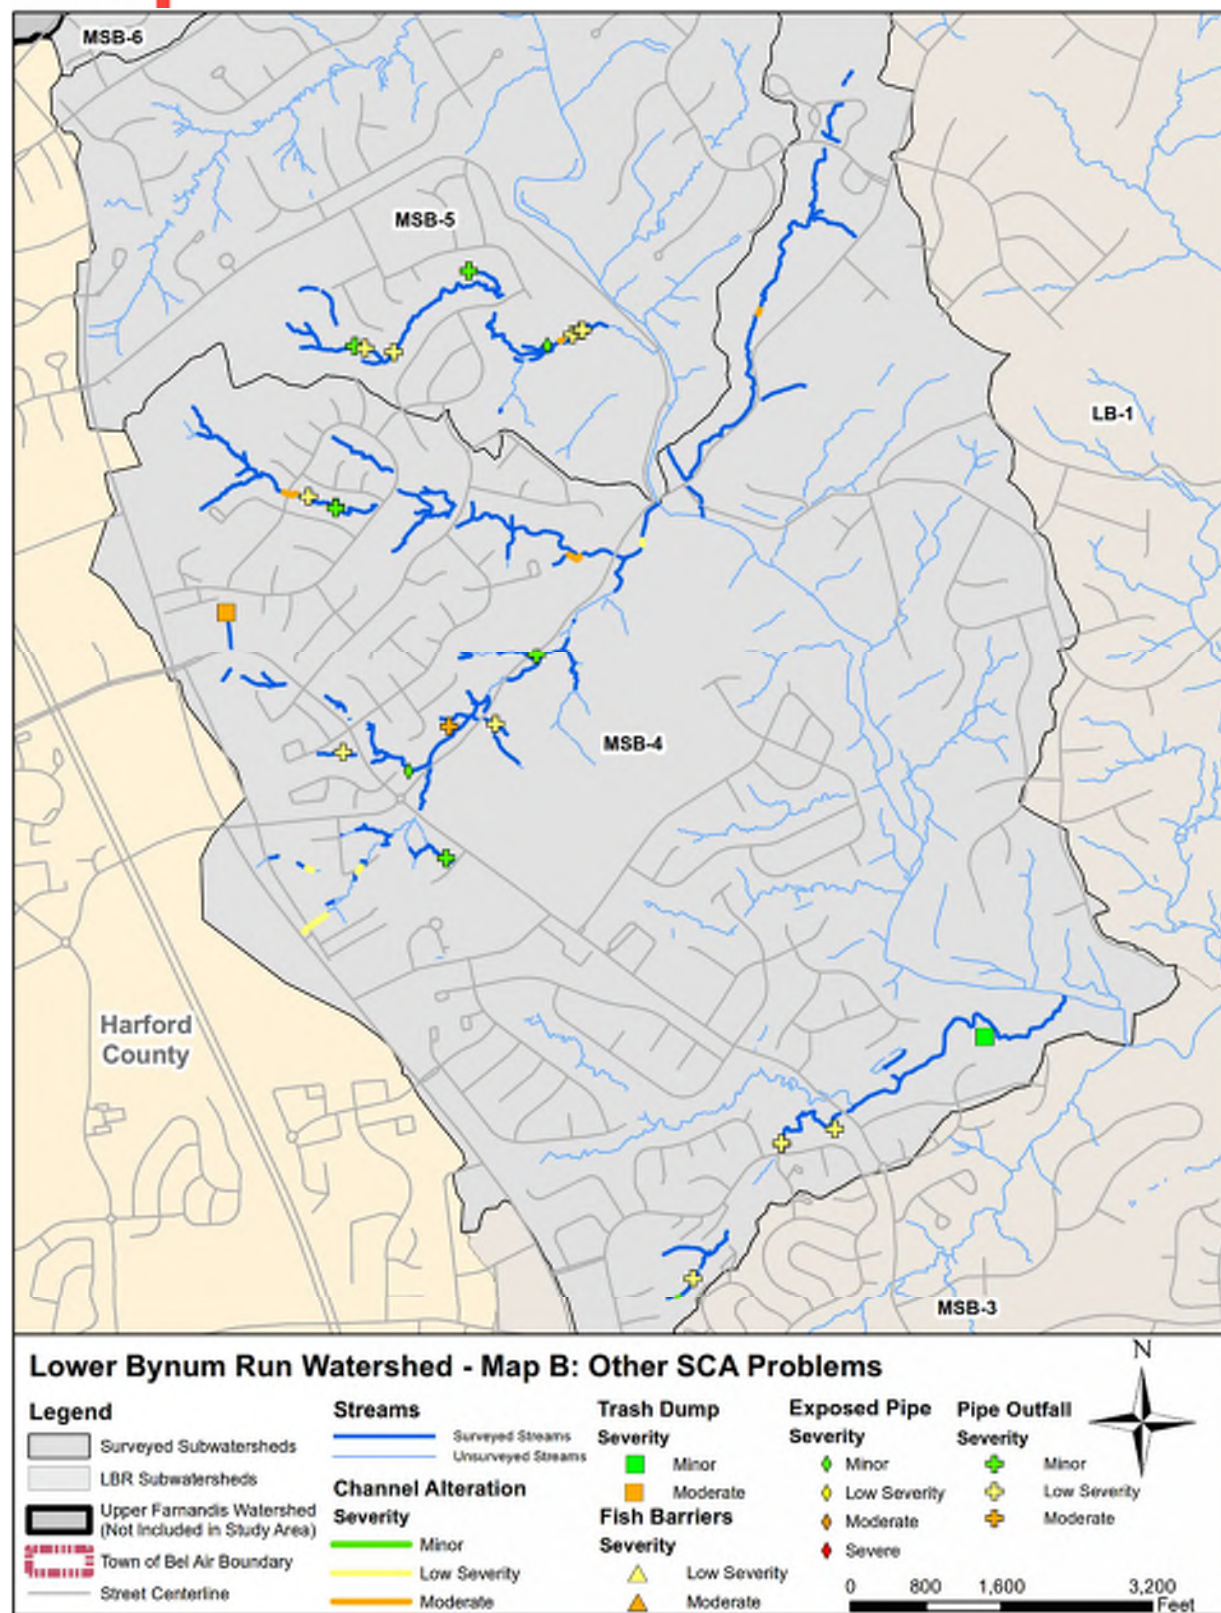
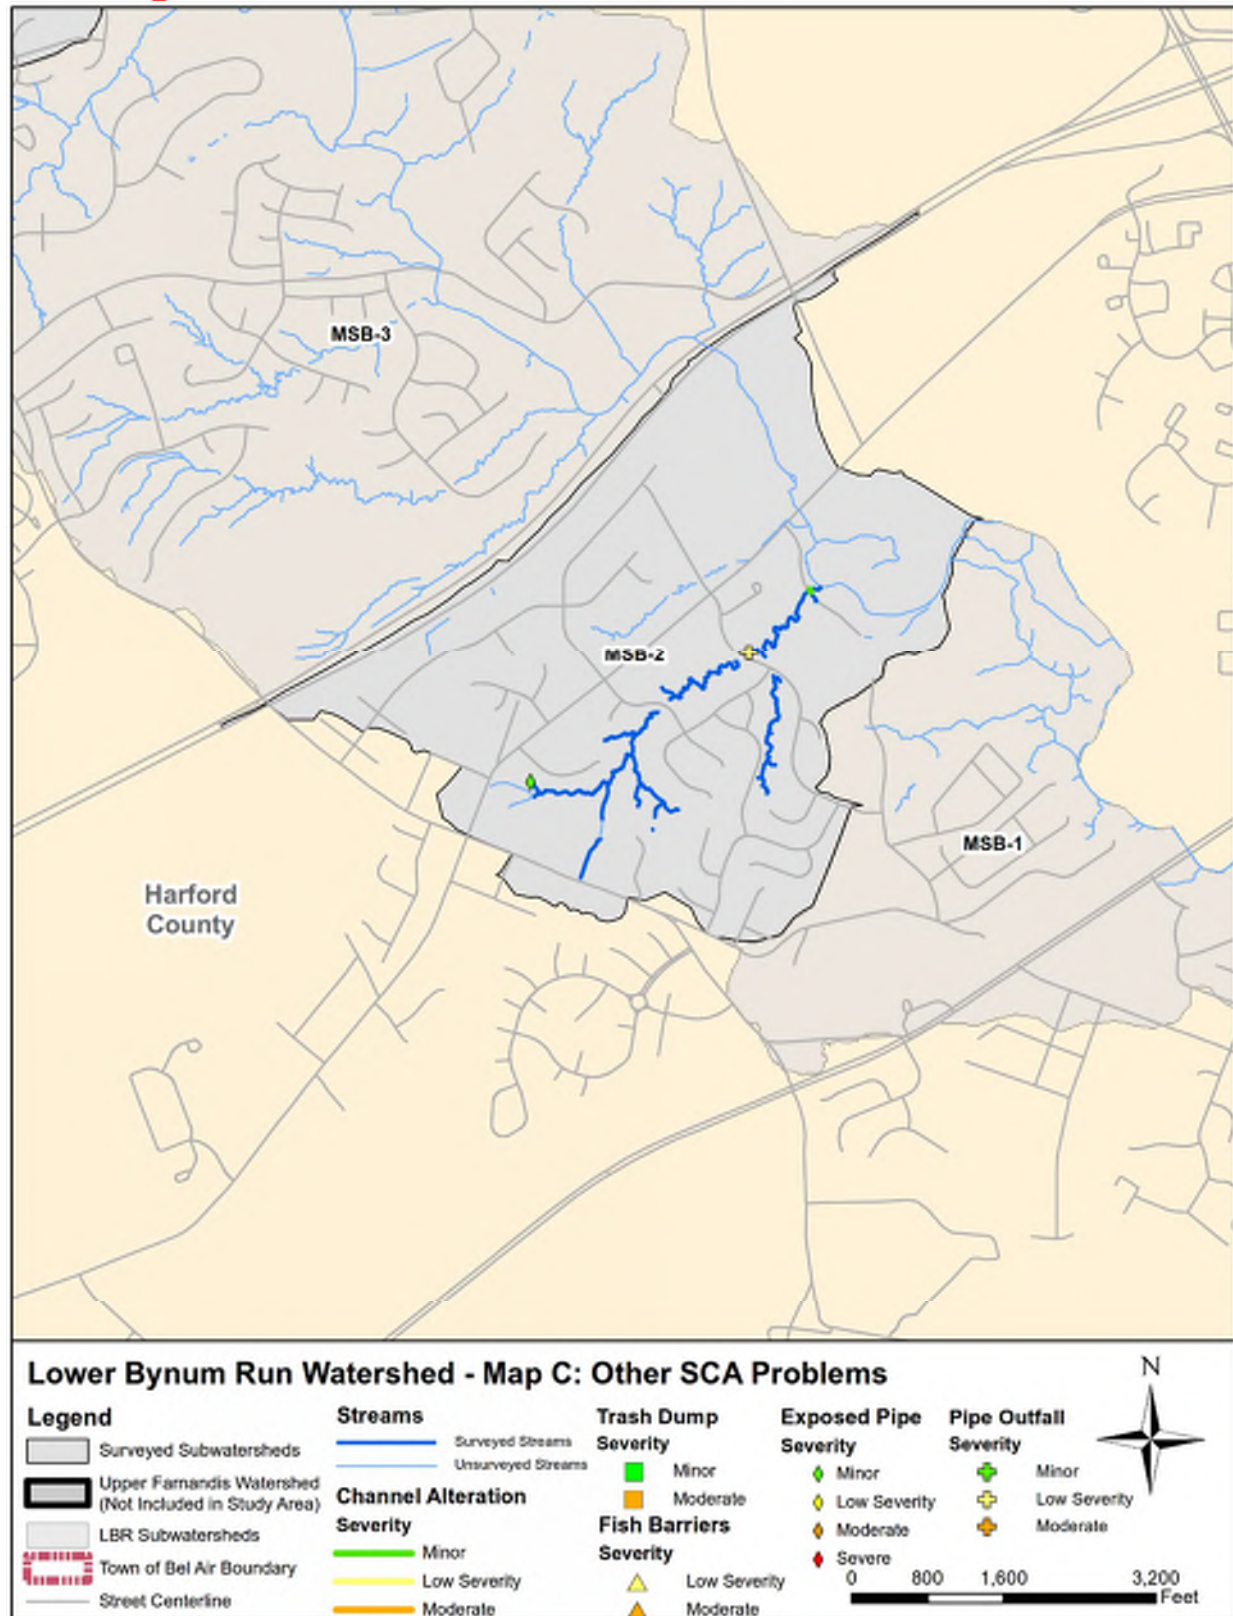
A total of 3 trash dumping sites were documented during the survey for the stream lengths surveyed. A moderate trash dumping was the highest ranking for the Lower Bynum Run watershed. The remaining sites inventoried for trash dumping were ranked minor. Both examples in Figure 4-23 are accessible and could be cleared by volunteers within a few days.
